# Fire in the Chunnel!

Ed Comeau and Alisa Wolf

*The first major incident in the world's largest underwater tunnel tested safety features and procedures. An NFPA fire investigation examines how well they worked.*

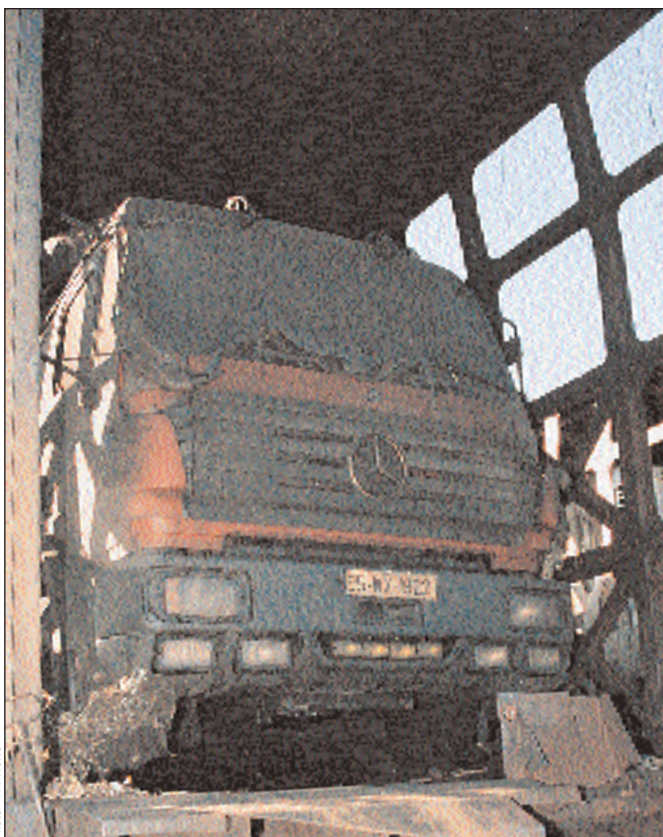
*The remains of a truck, which was one of many vehicles destroyed in the fire, is brought out of the Pas de Calais end of the tunnel.*

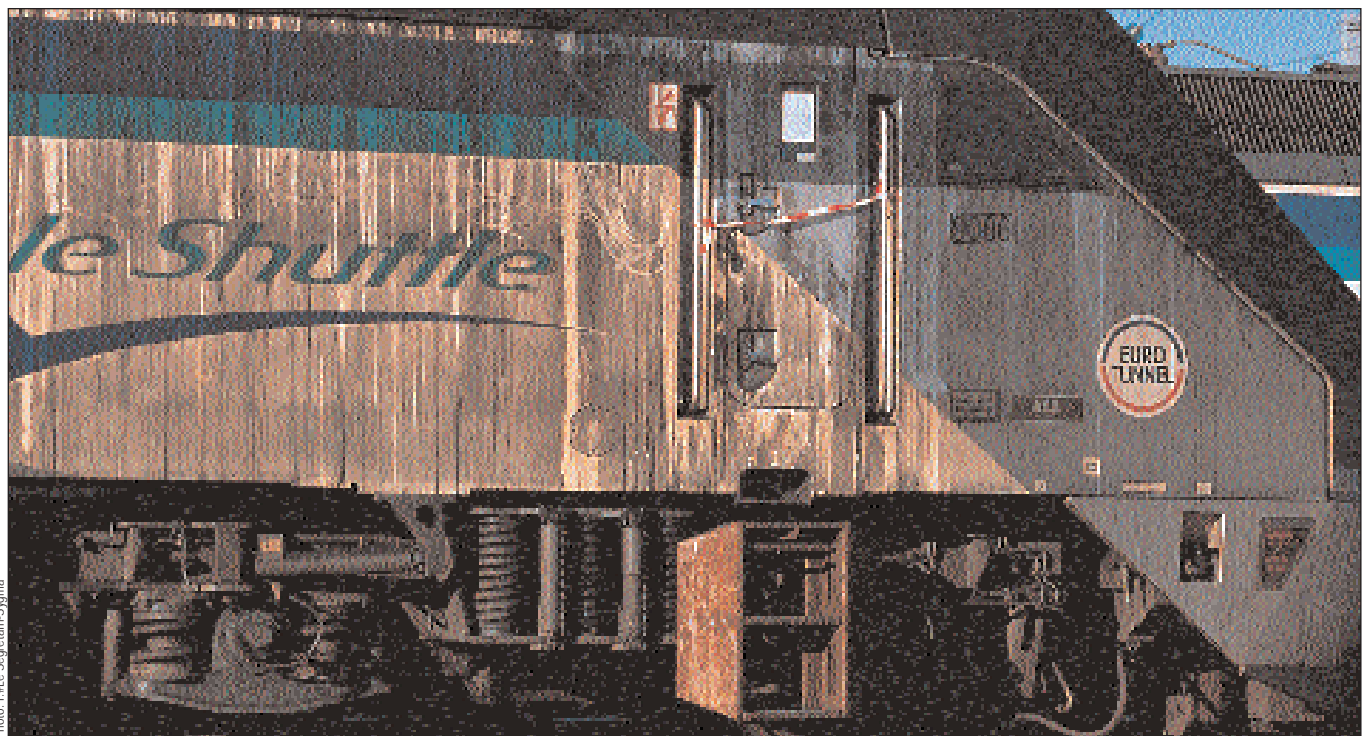
*A typical Eurotunnel "Le Shuttle" pulls 28 trucks, weighing up to 44 tons, through the tunnel on "carry wagons," one truck per carry wagon.*

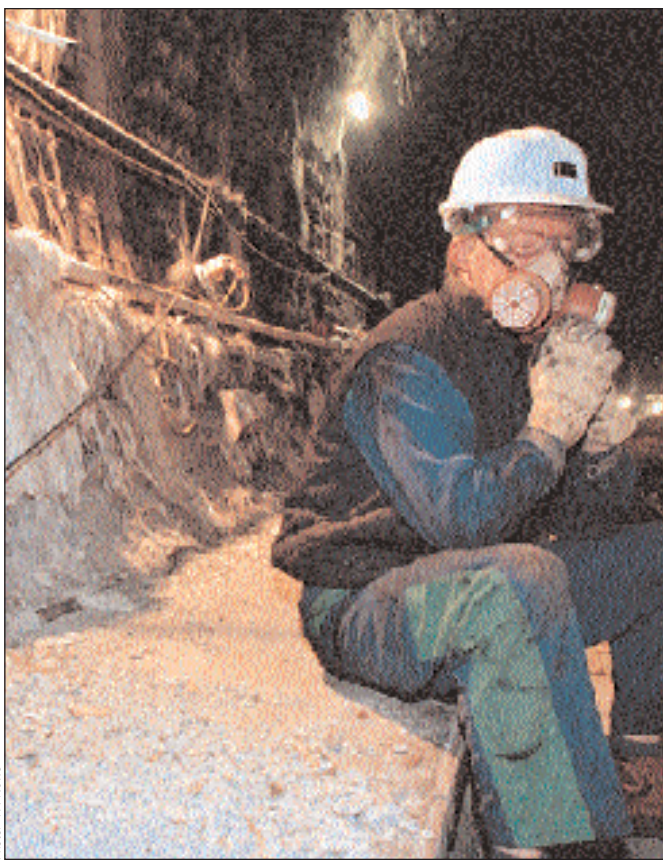
*A worker rests in the Chunnel in the aftermath of the fire. The heat of the blaze had caused pieces of concrete to fall from the tunnel's ceilings and walls, creating a sloping surface of debris in the tunnel walkways, as seen here in the background.*

Firefighters also had to dodge pieces of concrete falling from the tunnel ceilings and walls. They were advised not to look up in order to avoid injuries. This falling debris collected on the shuttle roofs, which ultimately collapsed into V shapes. The debris also collected on the tunnel walkways, creating a sloping surface that was difficult to walk on. It, too, was intensely hot, according to firefighters whose soles were burned from standing on them. Because of this difficult access, only one hose line each could be used on either side of the shuttle. U.K. responders trained a third hose line on the inside of the shuttle, but the trucks on the carry wagons made it difficult to advance this line.

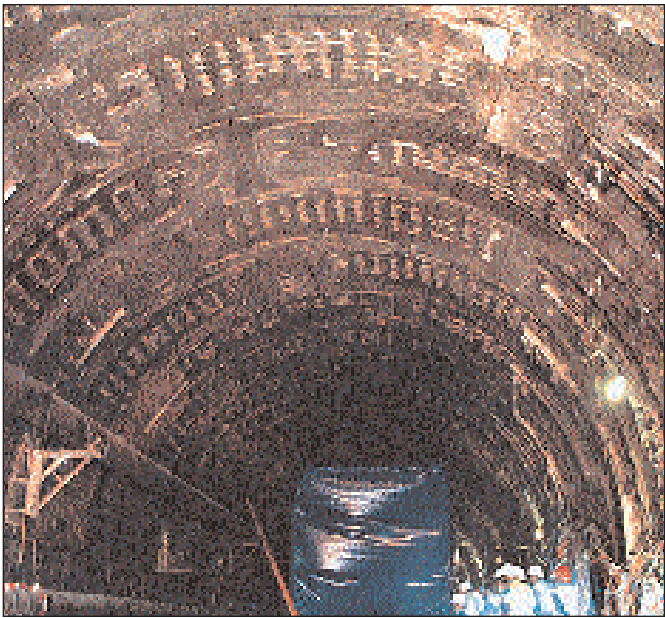
The burned-out interior of the Chunnel shows damaged concrete walls and ceilings eight days after the fire.

Eight trucks were destroyed in the blaze, and the rear loader and locomotive was damaged. The tunnel itself was significantly damaged. The fire’s heat dislodged the concrete liner. According to reports, as much as 16 inches of concrete were spalled away in some areas, leaving only 1 to 2 inches of liner between the tunnel and bedrock. Fiberglass insulation used in the tunnel was also released into the air, irritating the responders’ skin. All of the utilities and track in the immediate area of the fire were destroyed.
